## **Viking Energy Partnership**

### **Viking Wind Farm**

## **Technical Appendix 14.1 Peat Stability Assessment**

**March 2009**

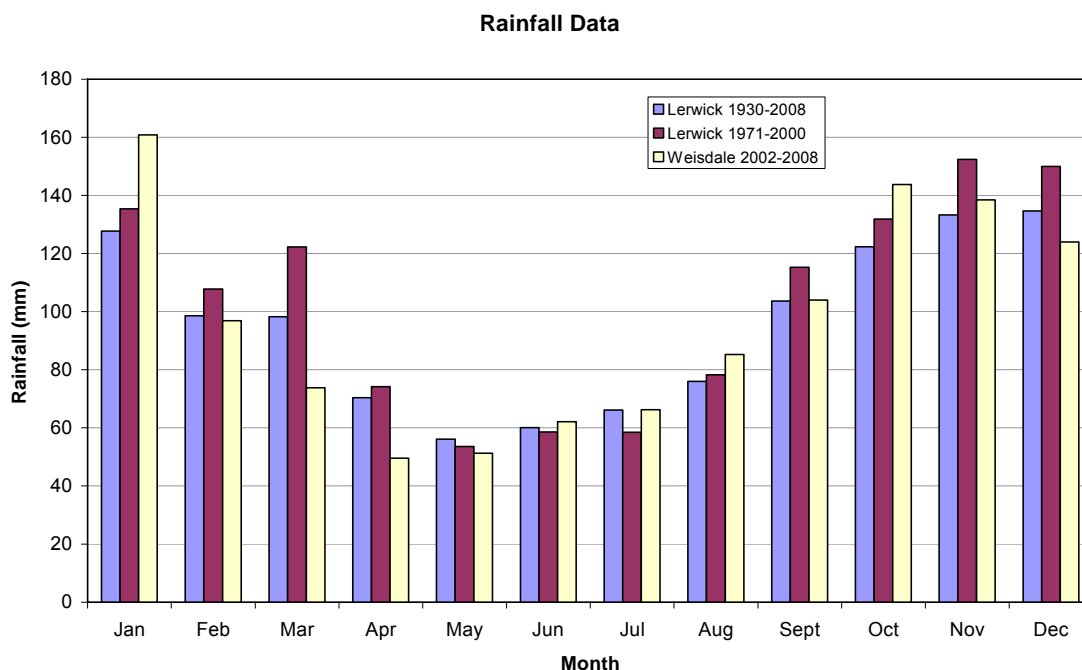
**Figure 1 Average monthly rainfall data for Lerwick and Weisdale monitoring stations**

Based on data collected from 1931 to the present day, the annual average rainfall for Lerwick is 1147mm. Average annual rainfall from the Weisdale monitoring station for the years with a complete dataset (2003-2007) is 1180mm. To put these data into a national context, rainfall in Scotland varies from over 3000mm per year in the Western Highlands to less than 800mm per year in eastern Scottish mainland areas.

For comparison, the average annual rainfall at Lerwick over the 1971-2000 reporting period is 1238mm, indicating a trend of increasing rainfall over recent decades. Changes in rainfall patterns between the different datasets suggest a slight decrease in rainfall in the summer

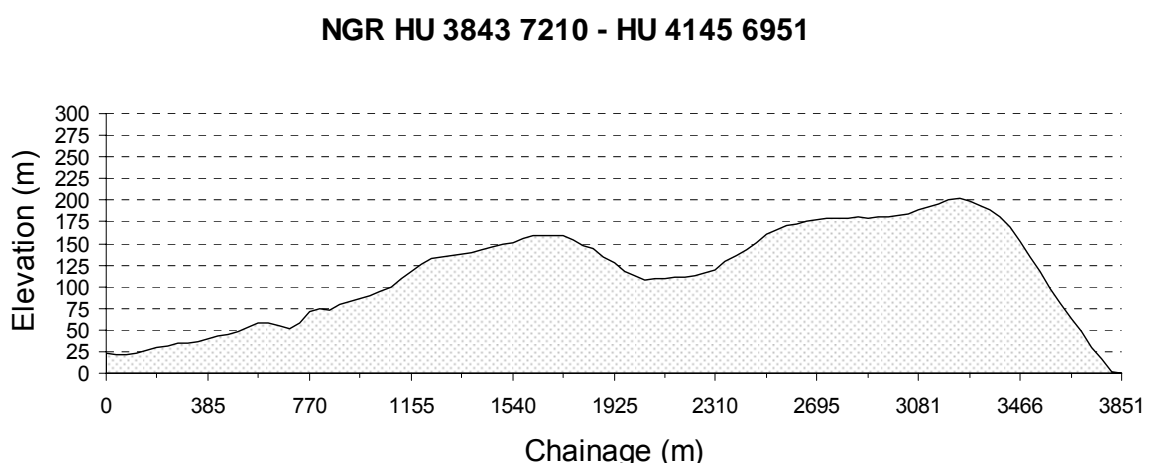
**Figure 2 Cross section through Delting quadrant, from Scatsta (NW) to Dales Voe (SE)**

The site centres on the settlement of Voe, HU 4086 6359, with two quadrants lying on either side of the A970-A968 route. The two quadrants west of this line, Delting to the north and Kergord to the south, typically show steeper slopes and higher elevations than the eastern quadrants. The eastern quadrants, Collafirth to the north and Nesting to the south, are characterised by more broken ridge lines with rounded hills and less pronounced valley sections.

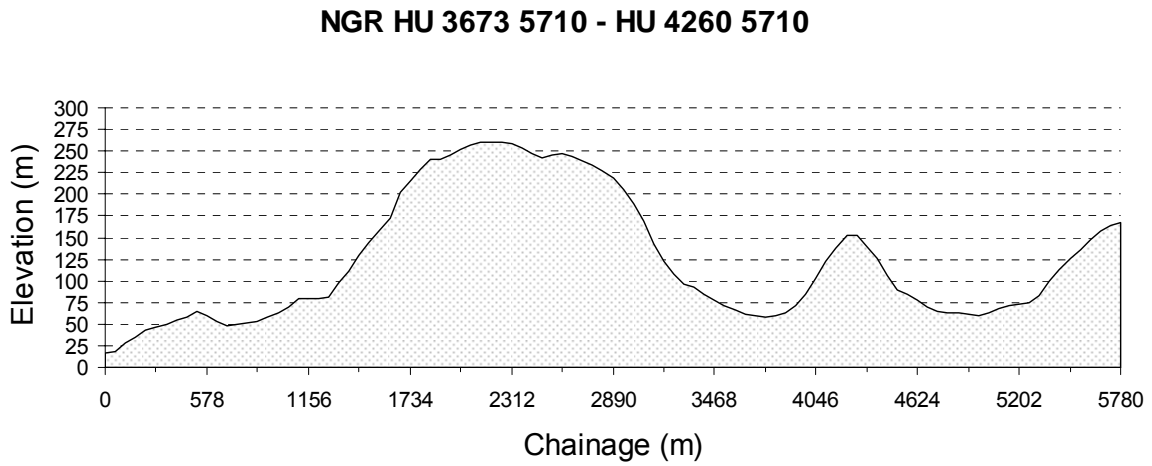
**Figure 3 Cross section through Kergord quadrant, from the South Burn of Burrafirth (W) to East Kame (E)**

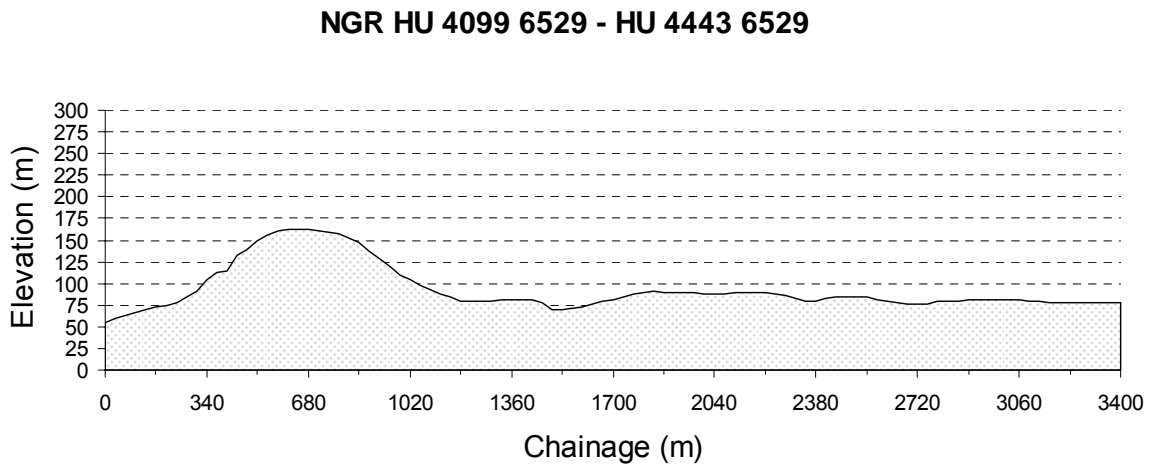
**Figure 4 Cross section through Collafirth quadrant, from Susetter (W) to Laxo Water (E)**

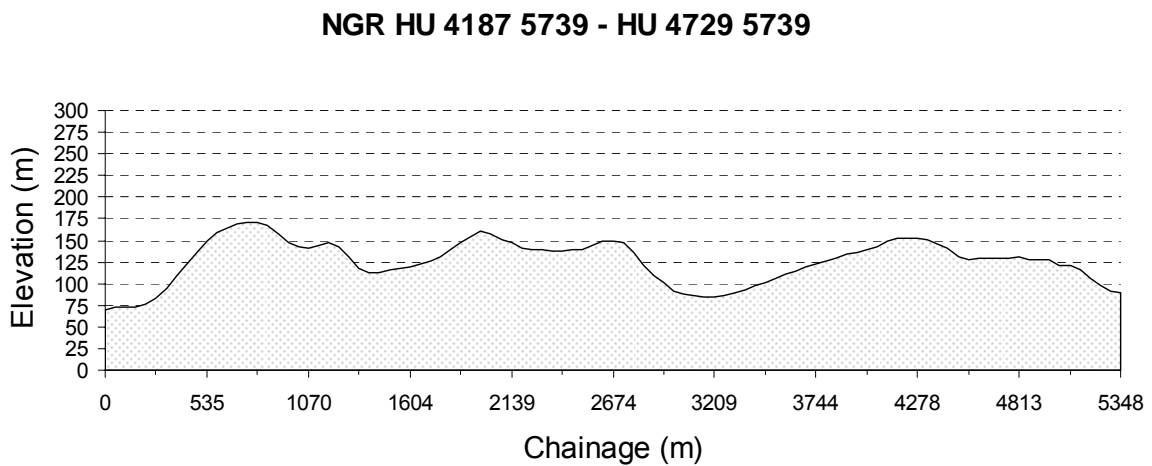
**Figure 5 Cross section through Nesting quadrant, from Petta Dale (W) to Brettabister (E)**

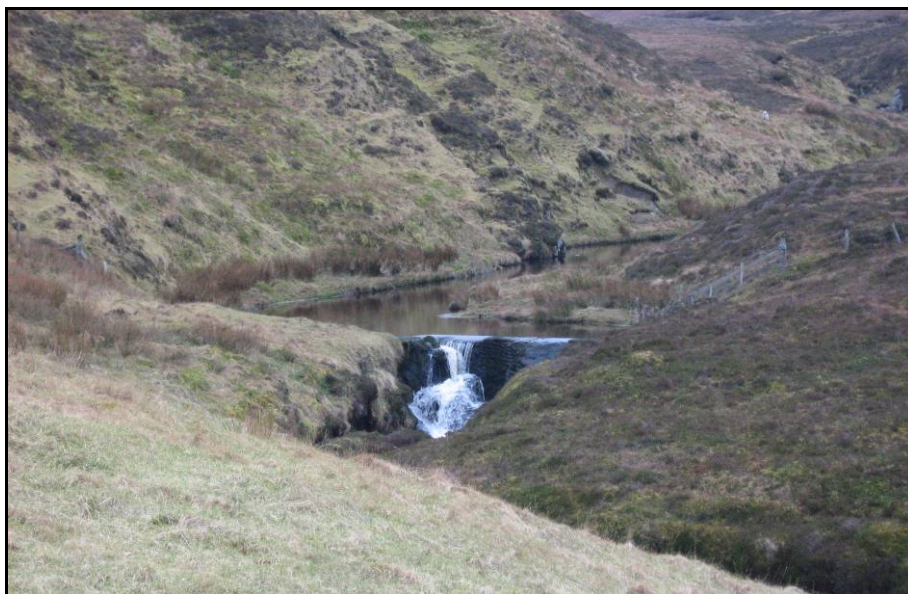
**Figure 12 Dam on the Burn of Laxobigging (HU 4166 7261)**

The Burn of Laxobigging has a redundant dam in its lower reaches, situated near the village of Graven (HU 4166 7261). This artificial feature forms pool habitats upstream which may be considered of value and may contribute to water flow moderation at higher water levels. There are no significant standing waterbodies in the catchment.

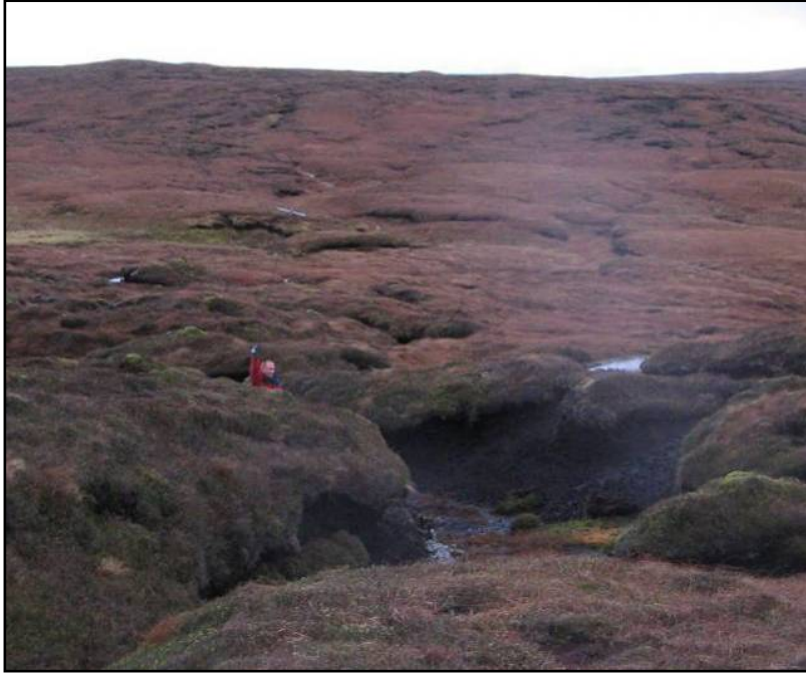
**Figure 31 Example of a peat gully, Turbine C41 (HU 4300 6478). At this point, the measured peat depth was 0.2m and the gully depth was 2m, giving a processed peat depth of 2.2m.**

Examples of gully and hagg environments are given in Figure 31 and Figure 32 respectively. The use of processed probing data tends to increase the numbers of deeper peat points and is consequently considered a more conservative approach for peat depth assessment.

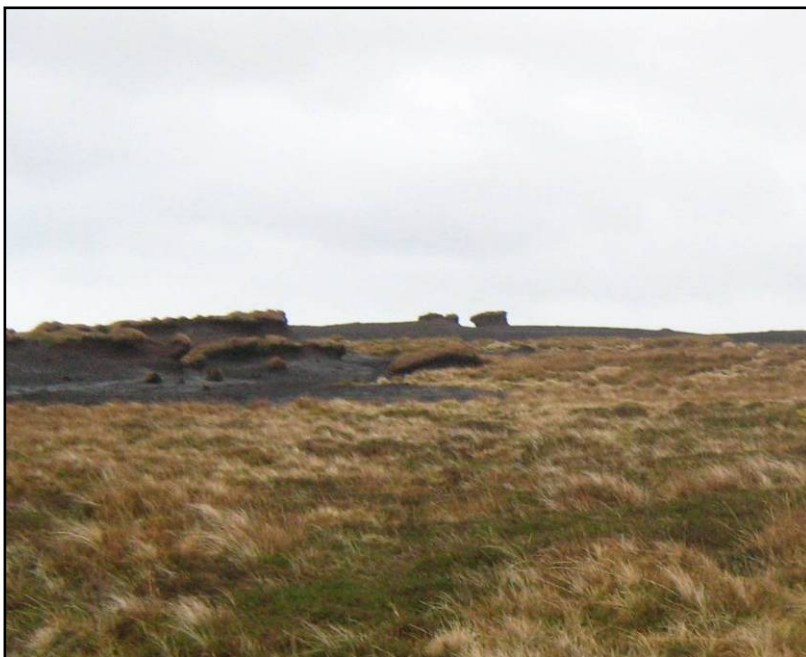
**Figure 32 Example of isolated hagg, near Turbine N117 (HU 4365 5672). The measured peat depth was 1.8m, and the peat hagg height was 1.5m, giving a processed peat depth of 0.3m.**

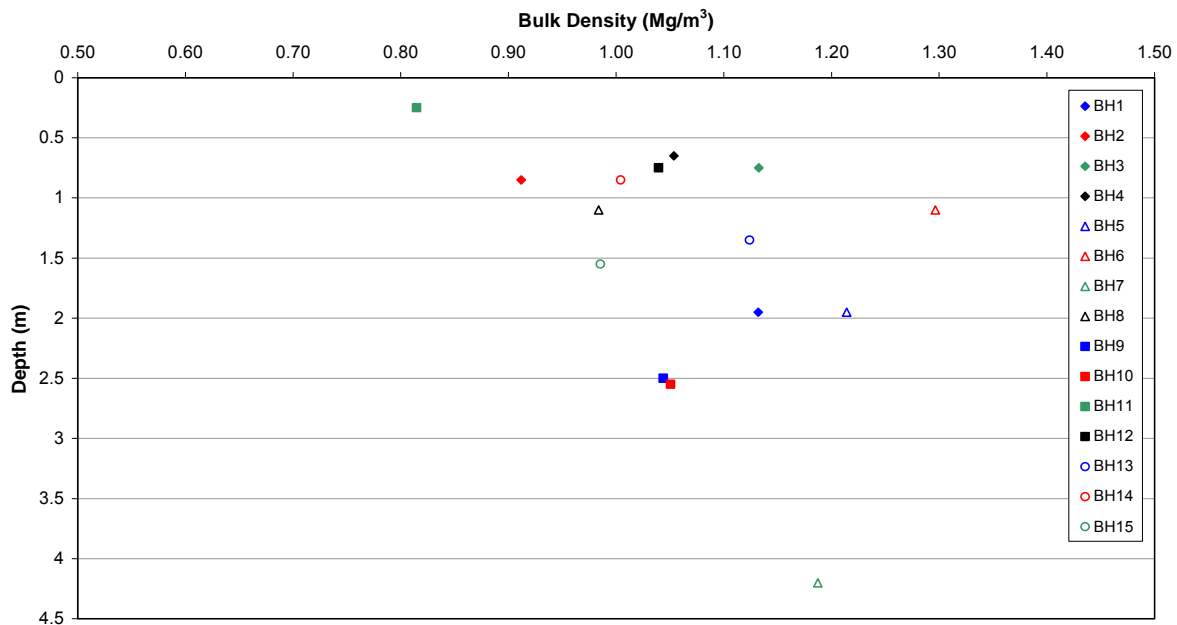
**Figure 37 Bulk density variation with depth**

The von Post classification of the peat showed a strong correlation with depth, with the degree of decomposition increasing with depth as would be expected. Shallow cores, up to 1m in depth, had von Post classifications between H2 and H4 (almost undecomposed to weakly decomposed), whilst cores from around 2m or greater depth returned von Post classifications of H6 to H8 (strongly to very strongly decomposed).

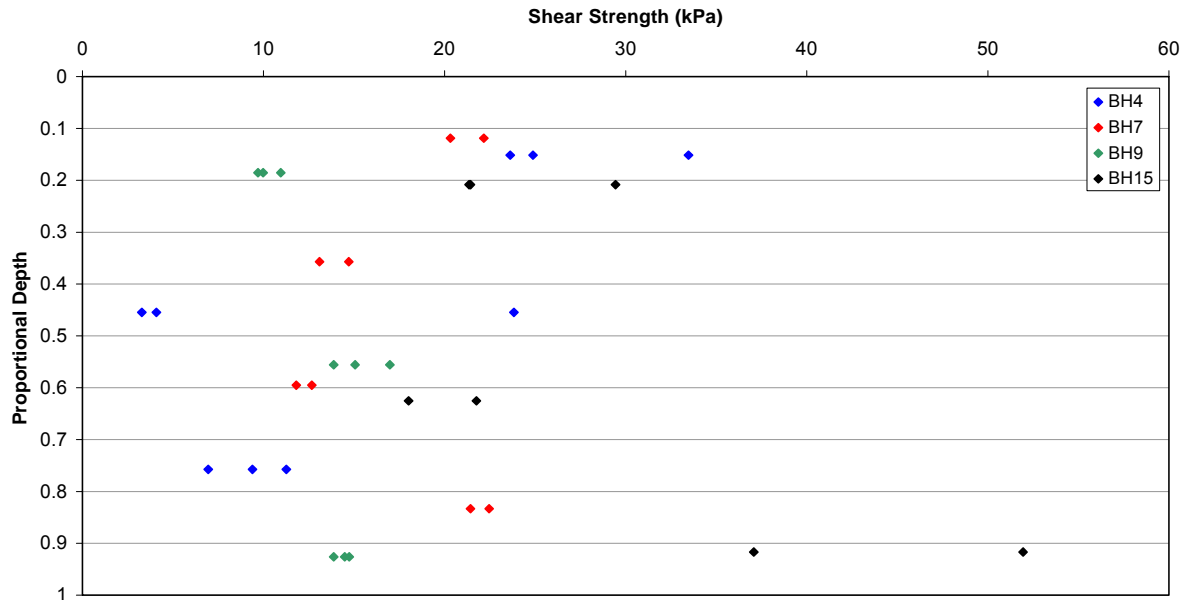
**Figure 38 Shear strength variation with proportional depth**

In most cases the slight increase in shear strength at the base of the peat may result from the presence of a transitional gley-like material. The exceptionally high results returned from the base of BH15 are more likely to represent shear strength of the underlying drift material rather than peat as they are outwith the usual range of peat shear strength values.
