Technical Appendix 2.1: Project Description Details

APPENDIX 2.2: OUTLINE CONSTRUCTION TRAFFIC MANAGEMENT PLAN

Peat Landslide Hazard and Risk Assessment
Prepared for: Viking Energy Ltd

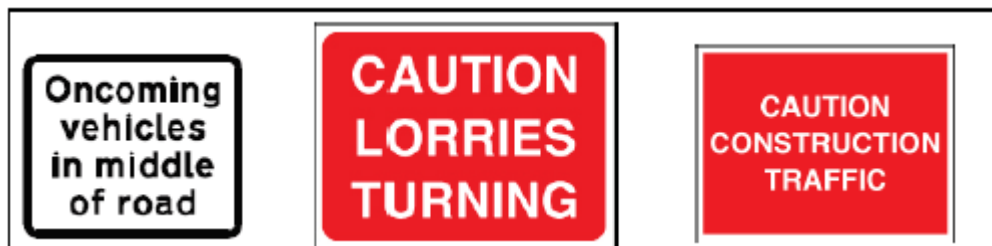
Figure 2.1: Example Construction Signage

Temporary construction site signage would be erected on the local road network in the vicinity of the proposed development site to warn people of construction activities and associated construction vehicles. The purpose of such signage is to provide driver information and to maintain road safety along the construction vehicle route. The exact nature and location of the signage would be agreed with the relevant authorities. Figure 2.1 illustrates examples of the type of signage which could be utilised.

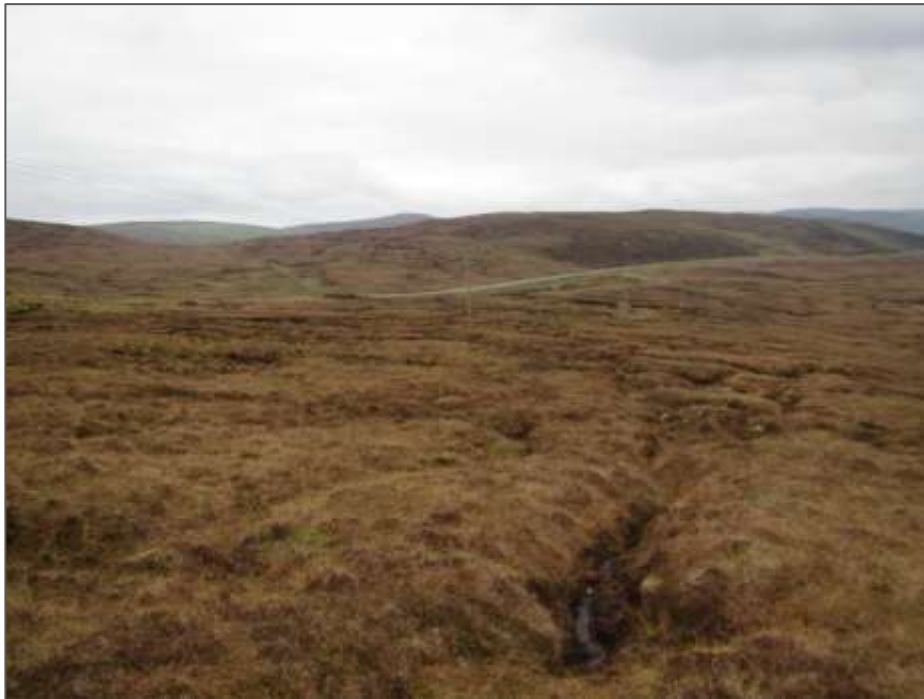
Photograph 2-1
General view of ground conditions at North Construction Compound

Photograph Location: 441610, 1160364, Direction of View: Northwest

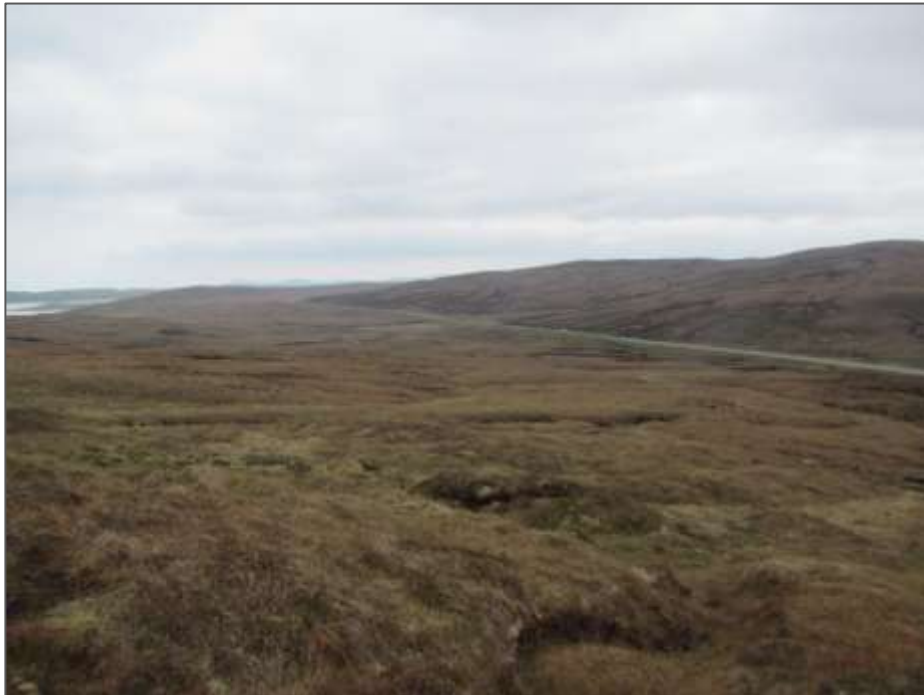
Photograph 2-2
General view of ground conditions at Main Construction Compound

Photograph Location: 442190, 1155053, Direction of View: South Southwest

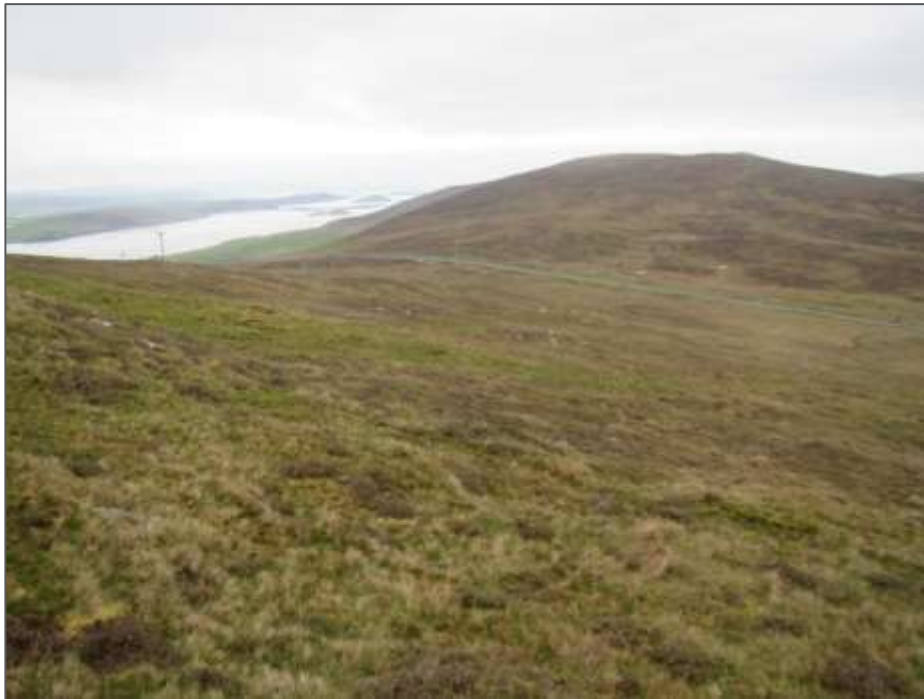
Photograph 2-3
General view of ground conditions at West Construction Compound

Photograph Location: 437707, 1150835, Direction of View: South

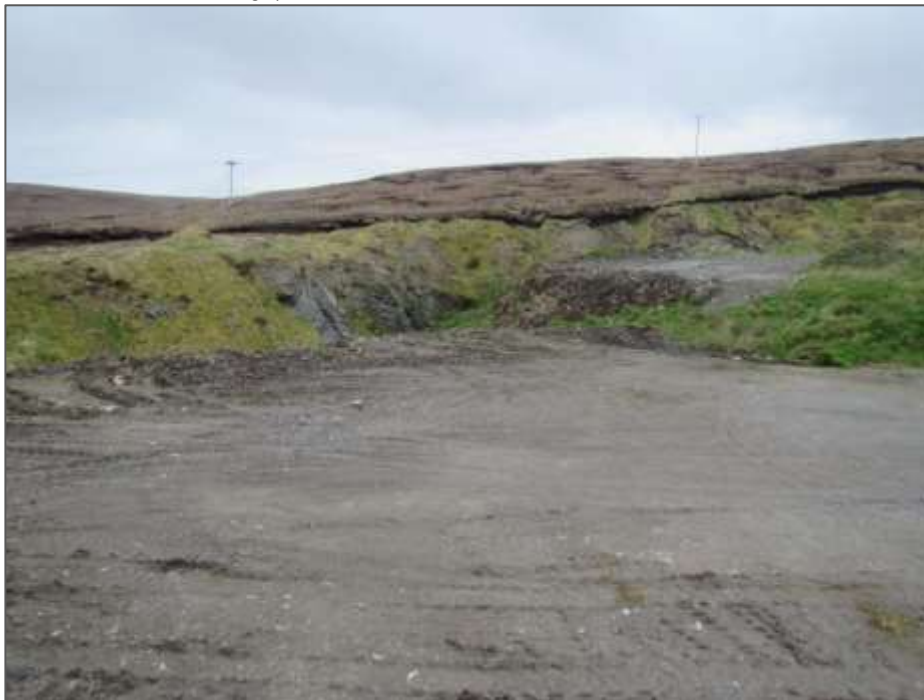
Photograph 4-1
Disused quarry at North Construction Compound

Photograph Location: 441498, 1160272, Direction of View: Northeast

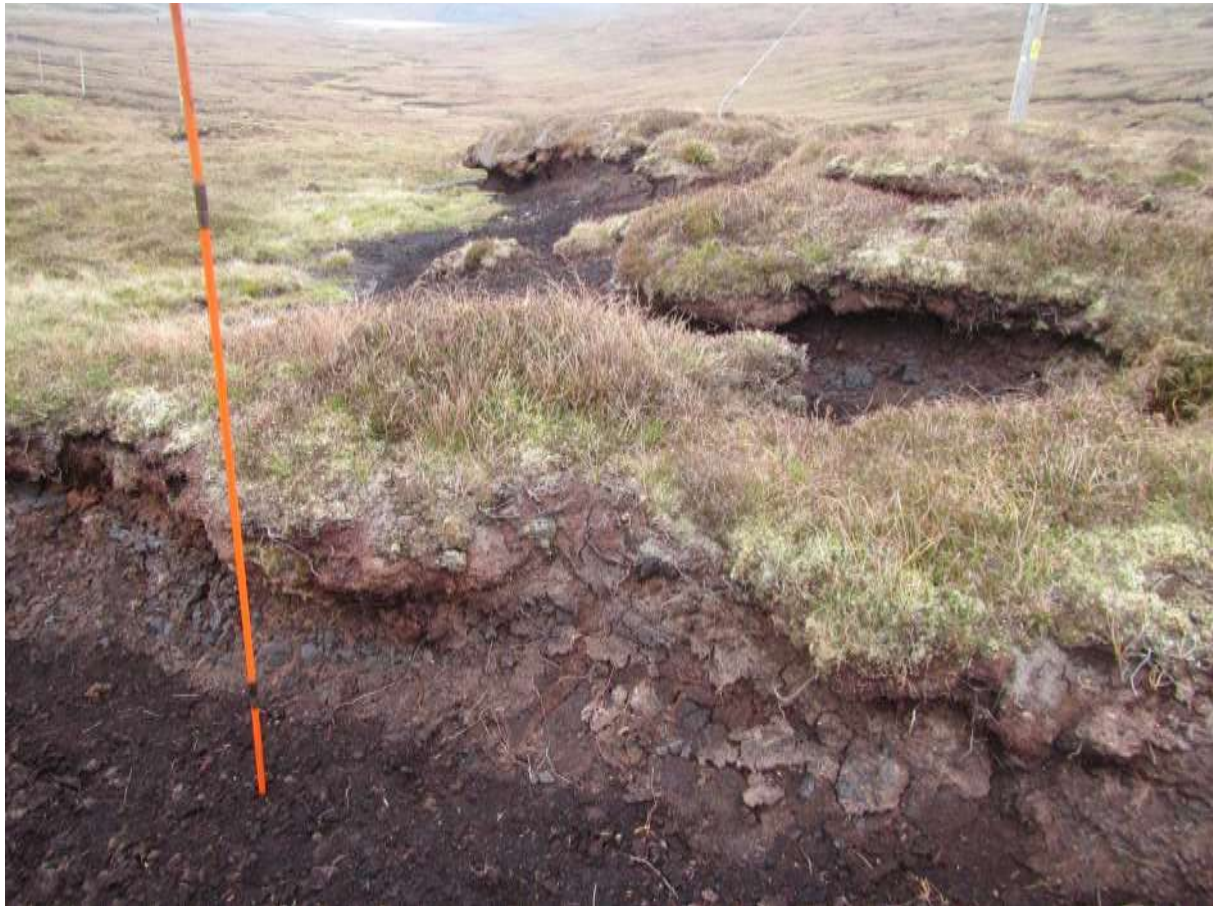
Photograph 6-1
Haggy Peat Deposits – North Construction Compound

Photograph Location: 441531, 1160370, Direction of View: North

The peat was found to vary across the site in terms of thickness and coverage. The thickest peat was generally limited to the east of the site. Part of the site is situated on a disused quarry where peat/peaty soils have been removed. The majority of probes (approximately 60%) across both phases of peat probing identified peat (> 0.5 m) of which approximately 29% was classified as thick peat (>1.5 m). The peat identified on site was highly fibrous and often eroded, with peat hags present on site (Photograph 6-1)).

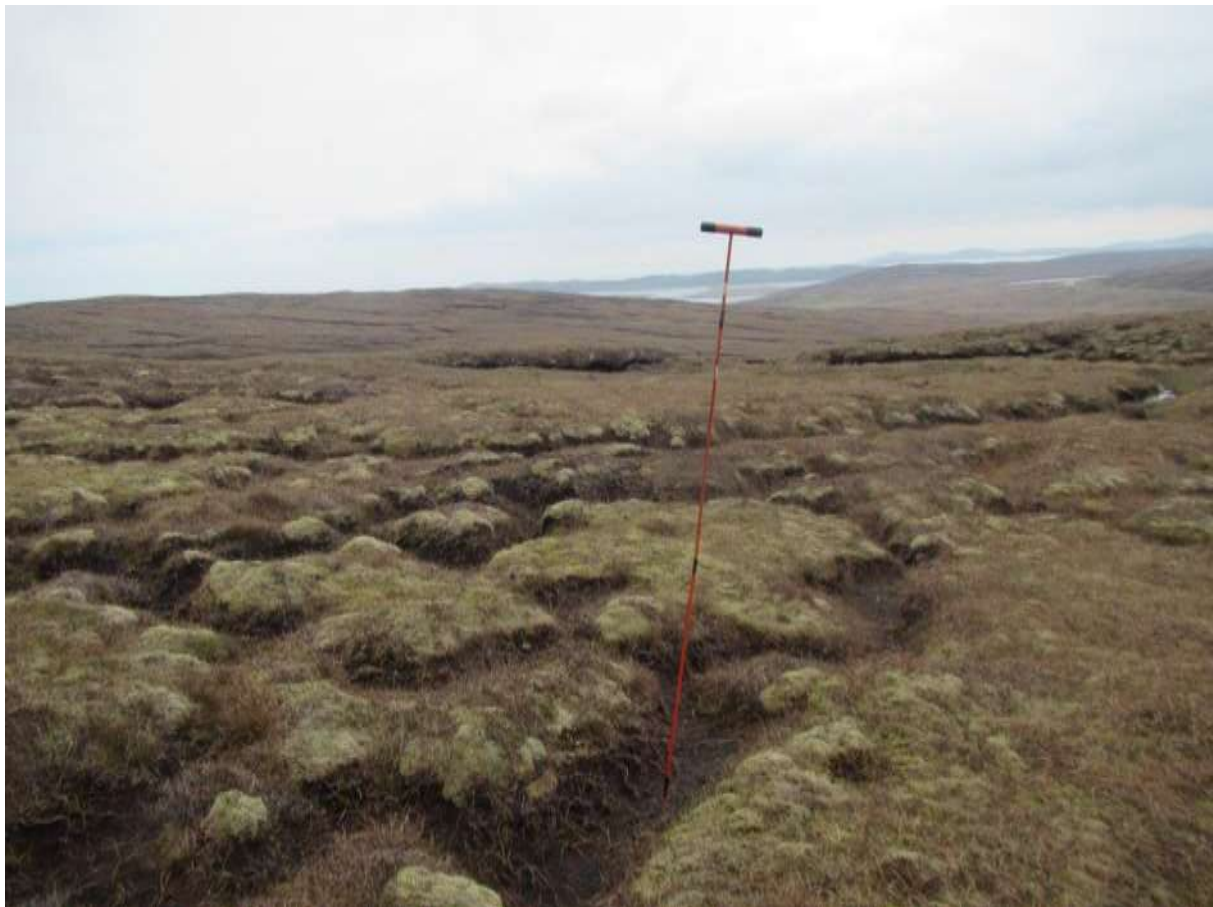
Photograph 6-2
Haggy Peat Deposits – Main Construction Compound
Photograph Location: 442116, 1155074, Direction of View: South

The peat found on the Main Construction Compound site was generally consistent in coverage and thickness with the thickest peat situated to the north and west of the site. The majority of probes (approximately 90%) across both phases of peat probing identified peat (greater than >0.5 m) with 34% of all probes intersecting thick peat (>1.5m). The peat identified on site was highly fibrous and often eroded with peat hags present on site Photograph 6-2.

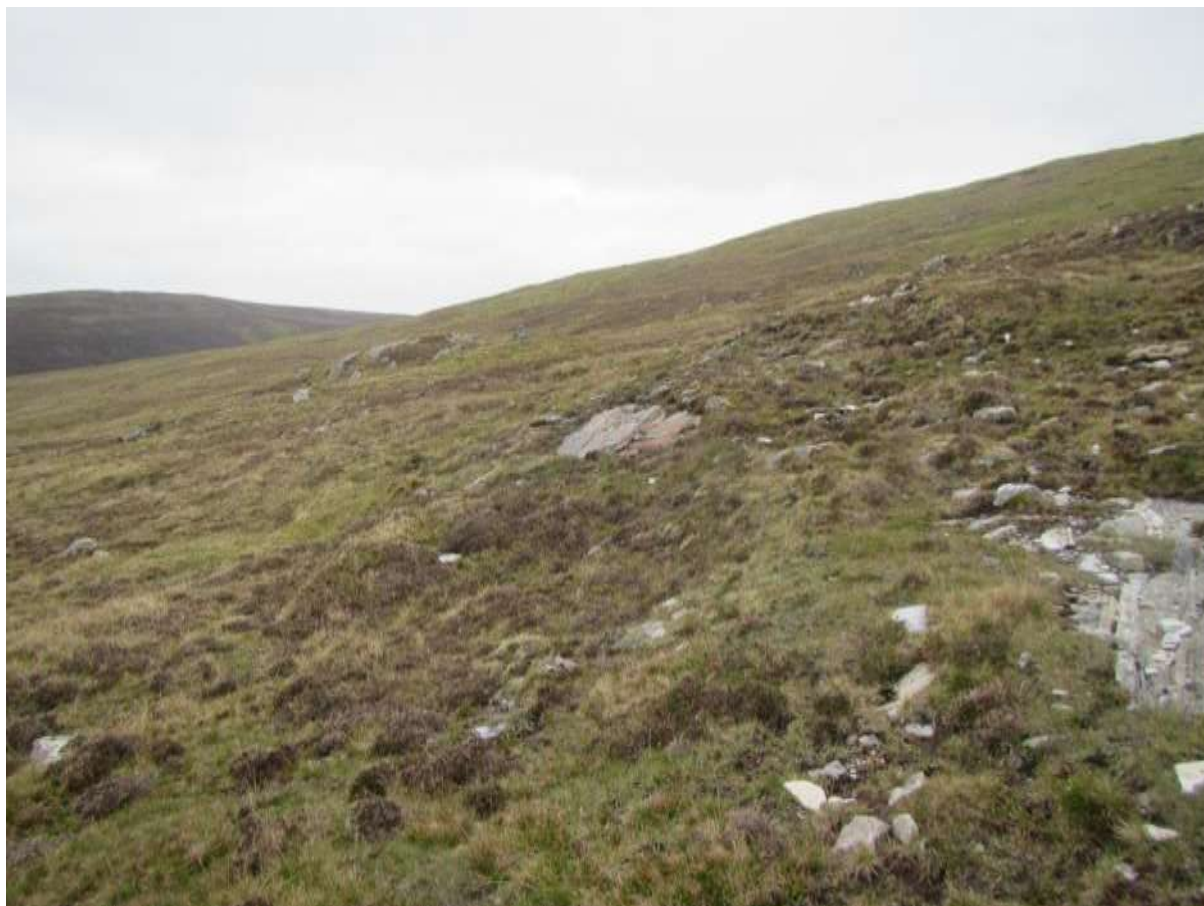
Photograph 6-3 Bedrock outcropping – West Construction Compound

Photograph Location: 437637, 1150680, Direction of View: North

- Approximately 12% of peat probes undertaken across the entire site found soils in excess of 0.5 m thick and no greater than 1.0m;
- Peat is very limited across the West Construction Compound site with thin soils over shallow rock prevalent.
